Independent Review of Aurora Network – summary of findings

Michael Van Doornik, Manager Advisory (VIC)

31 October 2018

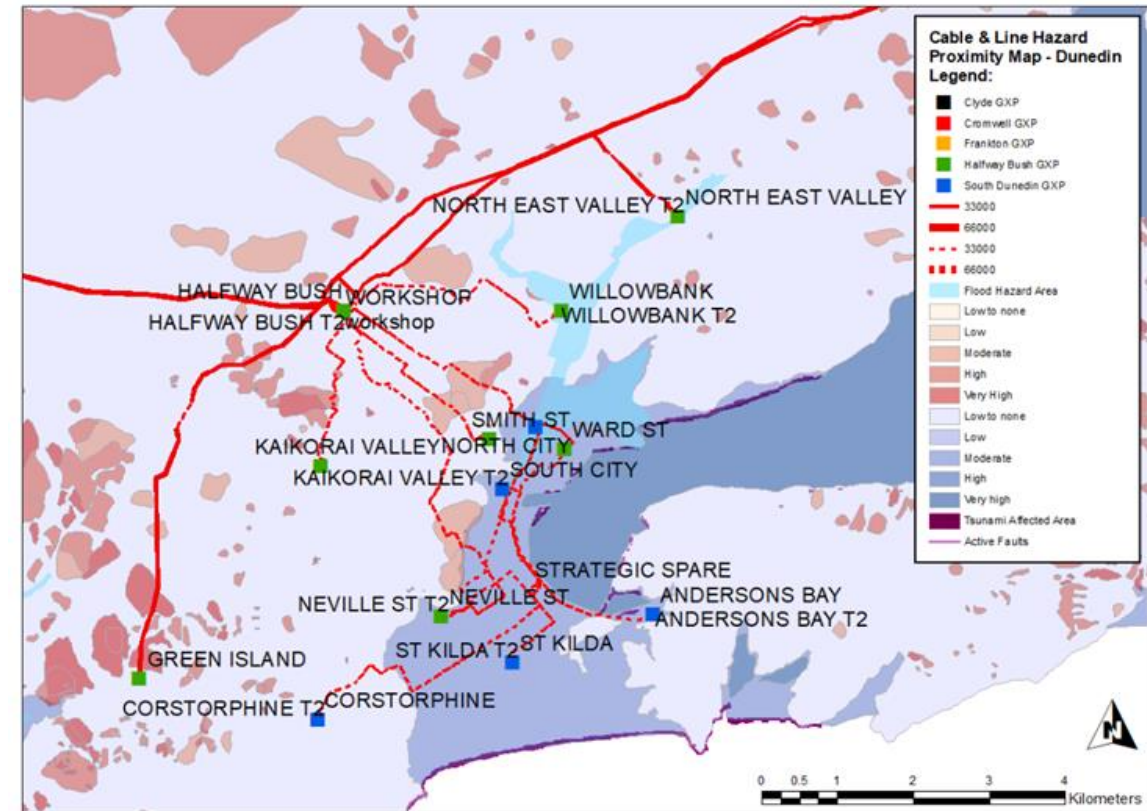
- The key resilience issues were related to liquefaction (earthquake) affecting the subtransmission cables in central Dunedin.
- Both subtransmission cables are in the same trench
- Other assets are not significantly impacted.

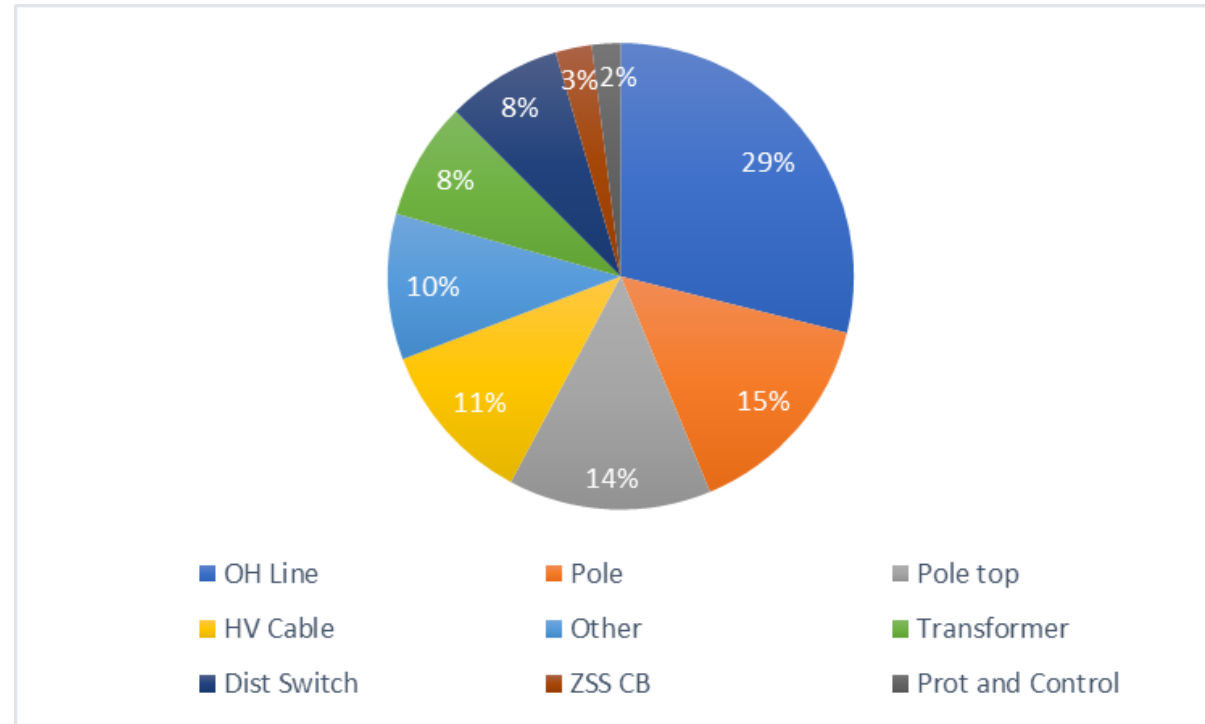
- Network performance, measured as SAIDI and SAIFI, has declined over the past 5 years with a slight improvement recently.
- OH lines, poles and cross arms cause 58% of unplanned outages from deteriorated assets.

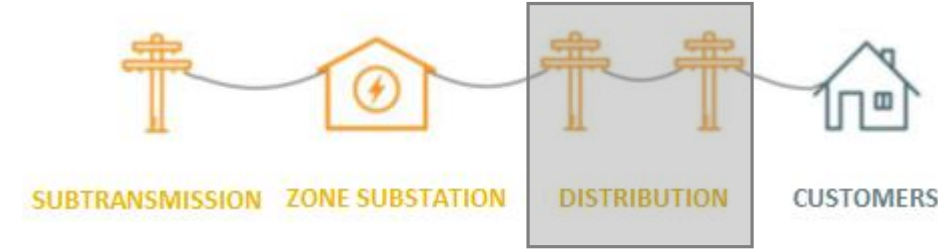
Distribution switchgear

9 assets in RED risk zone

- 9 distribution switches (0.1% of the fleet) have an elevated risk with respect to safety. The majority of distribution switchgear has low to moderate safety risk.
- The Long and Crawford (L&C) type of switchgear has resulted in recent failures in New Zealand and Australia and has a number of industry safety advice notices and an Order from EnergySafety (Western Australia) against it.
- Minor consequence score due to most of the L&C switchgear type being housed within a shelter and therefore reducing impact on public.

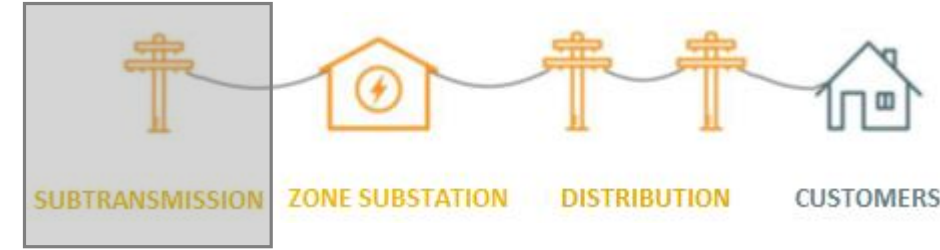
Key assets with Minor risks

- Sub transmission cables:
 - Oil and gas leaks evident and failed tests.
 - Due to redundancy currently not a big risk to network reliability, but expected to increase over time as all the cable is the same age and likely to have similar rates of deterioration.
- Sub transmission lines:
 - Marginally insufficient clearance between 66kV and 11kV circuits (1.8m compared to 2m in code) on the UC66-1 and UC66-2 lines (Cromwell to Wanaka). Construction issues have resulted in post insulators on a lean.
- Zone substations:
 - Alexandra 33 kV bus non compliance clearances to ground (can touch live bus from ground level). Field crew risk only.
 - Contractors not following latest Aurora inspection procedures (observation from Green Island, Alexandra ZSS visits).
 - Fire detection does not cover all rooms within substation buildings.
