Independent Review of Aurora Network – summary of findings

Michael Van Doornik, Manager Advisory (VIC)

31 October 2018

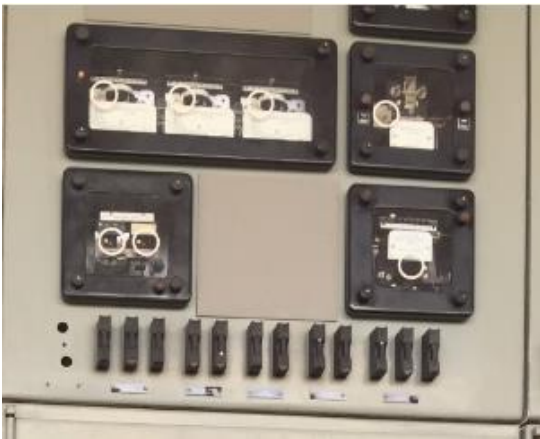
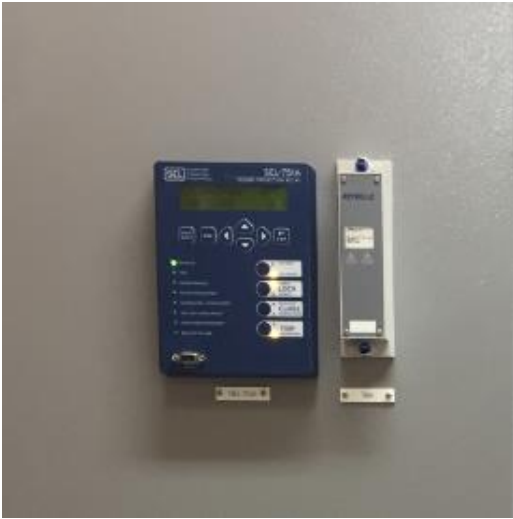
Protection systems

- A significant proportion of relays are approaching end of life
- Approx. 50% of relays pose a risk of not operating as intended
 - Loss of calibration of settings
 - Some instances where relays failed to operate (15 HV out of 278)
 - 30% of the CTs at Green Island ZSS failed testing
- Red Zone: elevated risk of faults not being isolated, possible:
 - Damage to equipment
 - Live lines on ground

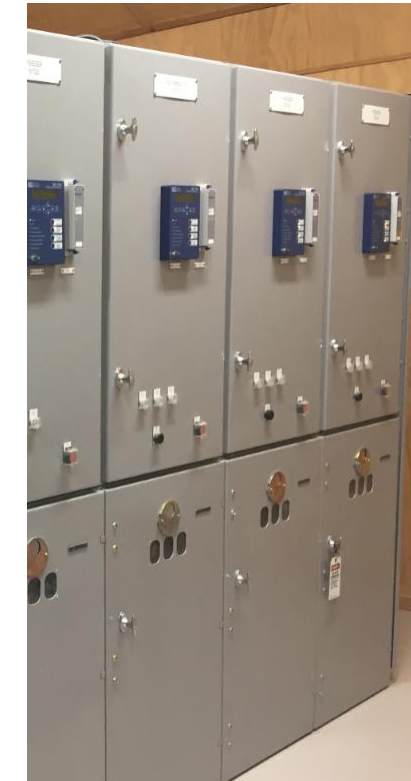
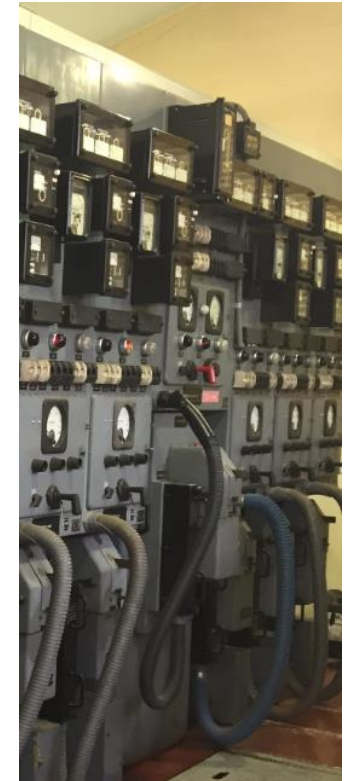
ZSS circuit breakers

- 148 circuit breakers (36% of the fleet) have elevated risk of failure:
 - A large proportion of circuit breakers have passed their nominal life (decom of Neville St will remove 34 old CBs)
 - Certain types have had failures in other electricity businesses
 - Maintenance of some CBs is not up to date
 - Some CBs not fully maintained internally
- Oil insulated circuit breakers have an elevated consequence of failure:
 - Risk of fire propagating through switchboard due to oil insulation
 - Predominately reliability risk, but a safety risk of work crew present.

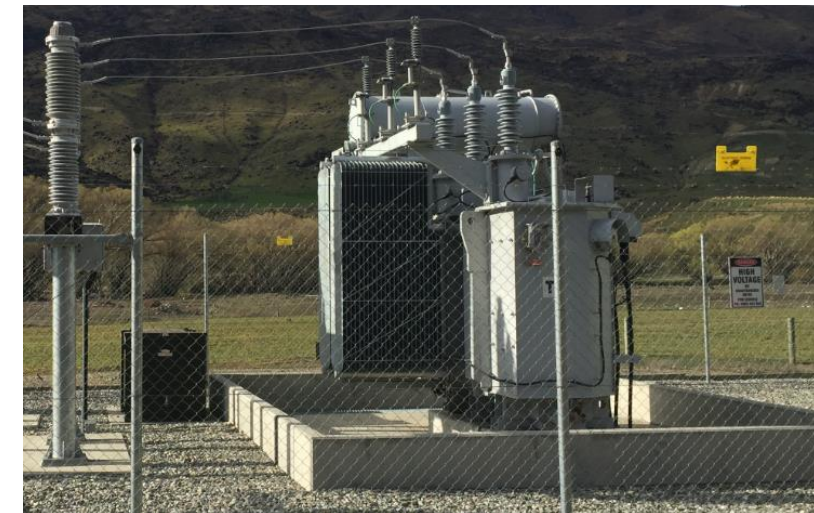
ZSS Transformers

- Risk assessment is driven by reliability, calculated as expected energy at risk. 8 transformers (out of 63) considered to have elevated risk, driven by:
 - Internal condition
 - Other components (tap changer)
- Two of the transformers with elevated reliability risk (at Neville St) are currently being replaced.
- East Taieri had a moderate level of safety risk – located adjacent to a petrol station. All others have a low safety risk.

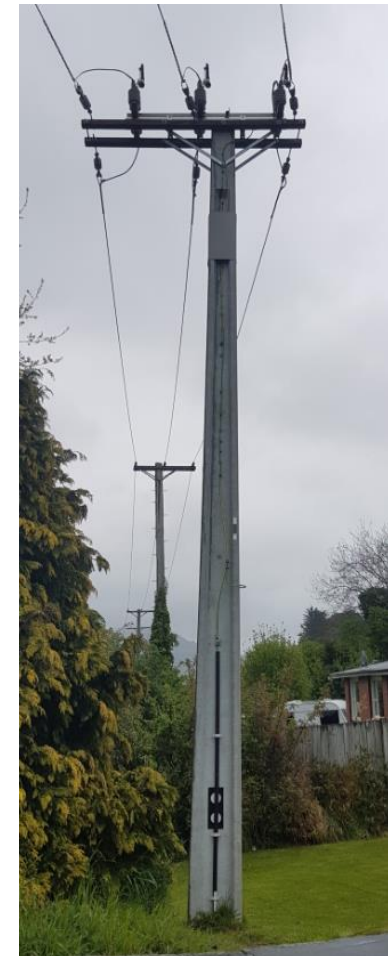
Support structures

- Public safety is the key risk driver for this asset class.
- 1,264 poles (4% of the Dunedin fleet) in Red risk zone in Dunedin (higher population density) and 104 poles (0.4% of the Central fleet) in Central.
- Poles appear to be showing a steady or slightly reducing level of failure – reflective of the recent focus on pole inspections and remediation.
- There is an emerging risk with cross arms – mostly due to increasing asset deterioration and defects.
