AURORA ENERGY

**INDEPENDENT REVIEW
OF ELECTRICITY
NETWORKS**

EXECUTIVE
SUMMARY

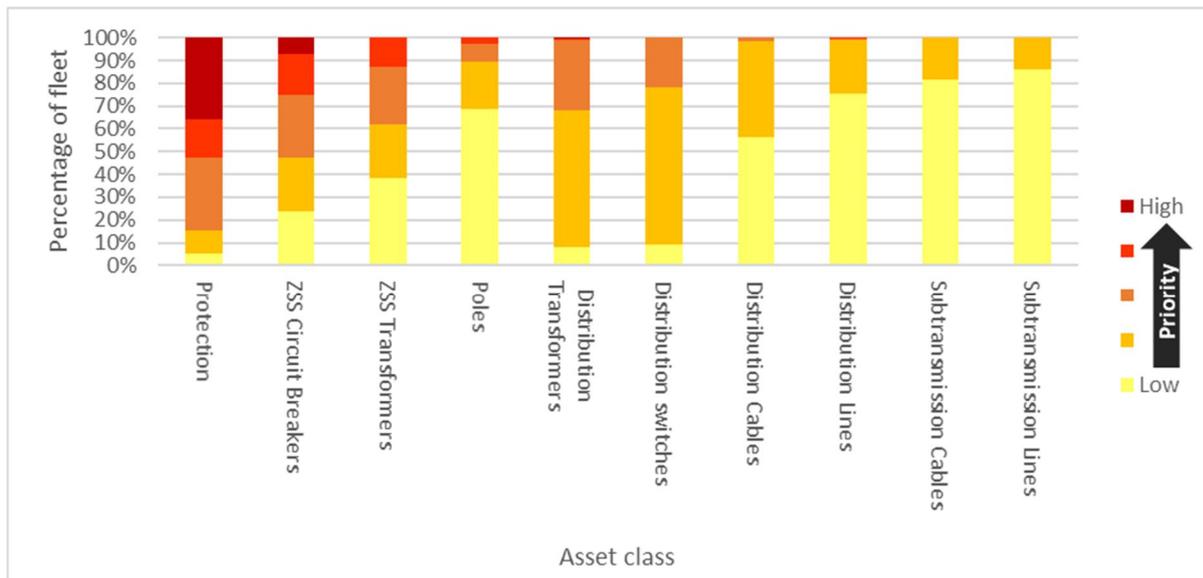
We used Aurora’s risk management approach to classify the identified risks. The table below shows the result.

Overall, we found a high number of risks in the “Red” category, indicating network risk has not been reduced to as low as reasonably practical.
